# Priority Panel Briefing Alabama Plating Site

*September 2015*

# Alabama Plating Superfund Site

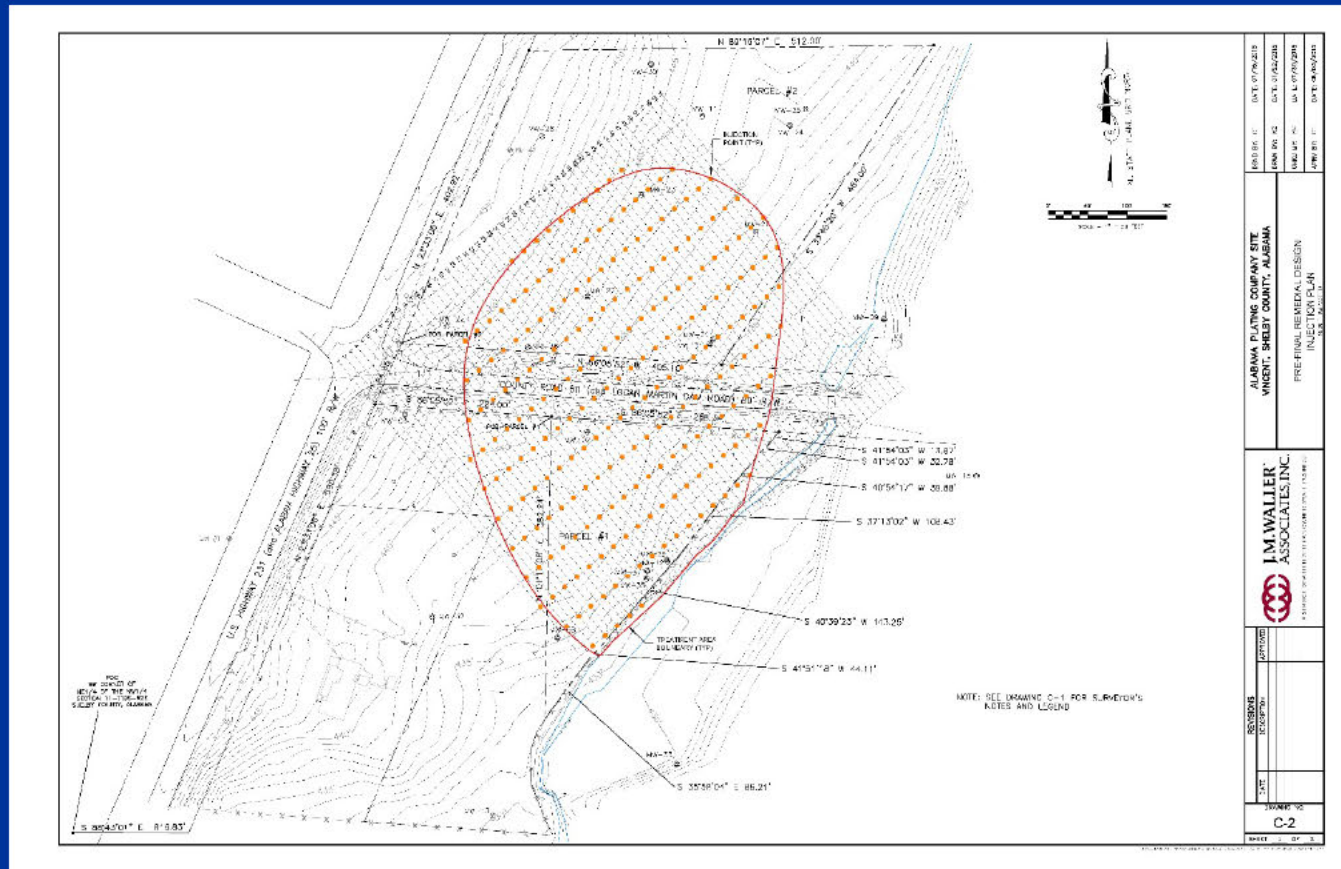
# Remedial Design

- Pre-Final RD completed in July 2015 that includes injection of calcium polysulfide at 230 points plus MNA monitoring plan.
